TECHNICAL MEMORANDUM

Date: September 27, 2010
To: Naren Prasad and Brian Bartoszek, Integrys Business Support
From: Sarah Meyer and Jennifer Kahler, Natural Resource Technology, Inc.
Subject: Supplement to *Characterization of Ambient Conditions in the Chicago River Upstream of the North Branch MGP Sites*

Enclosure A: Photo Log of Source Area Features

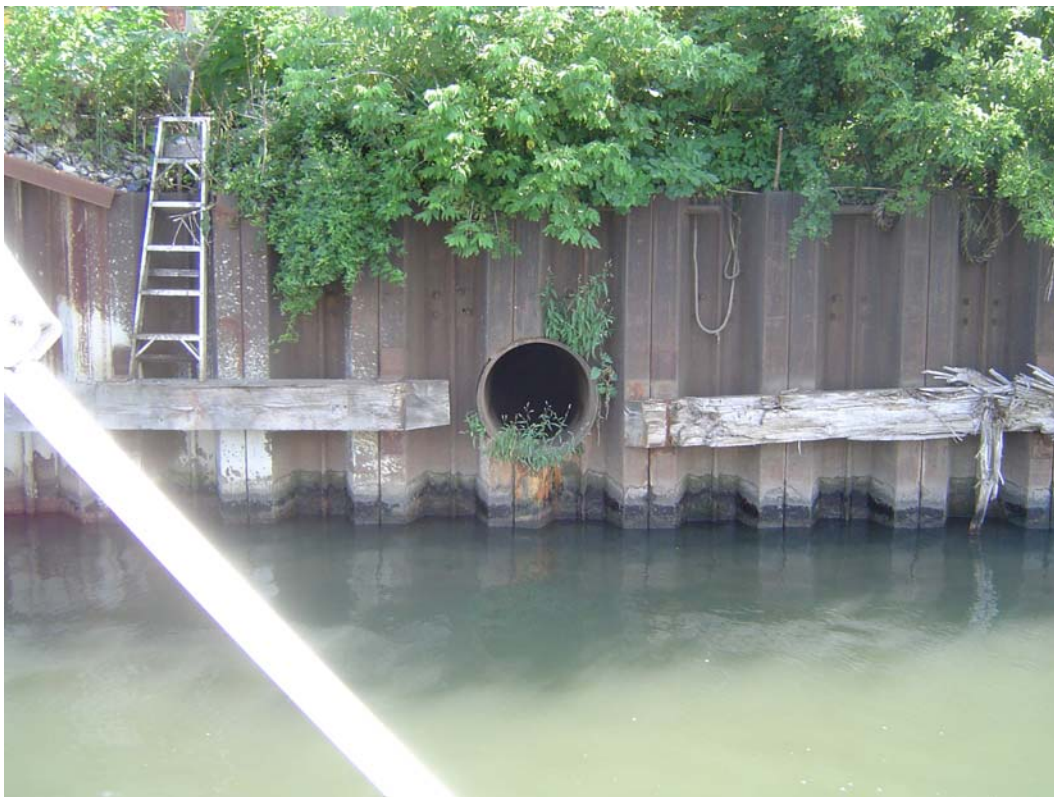
Photo 070710-01: Medium-sized, dry pipe south of General Iron (GI) processing plant. S. Meyer, July 7, 2010.

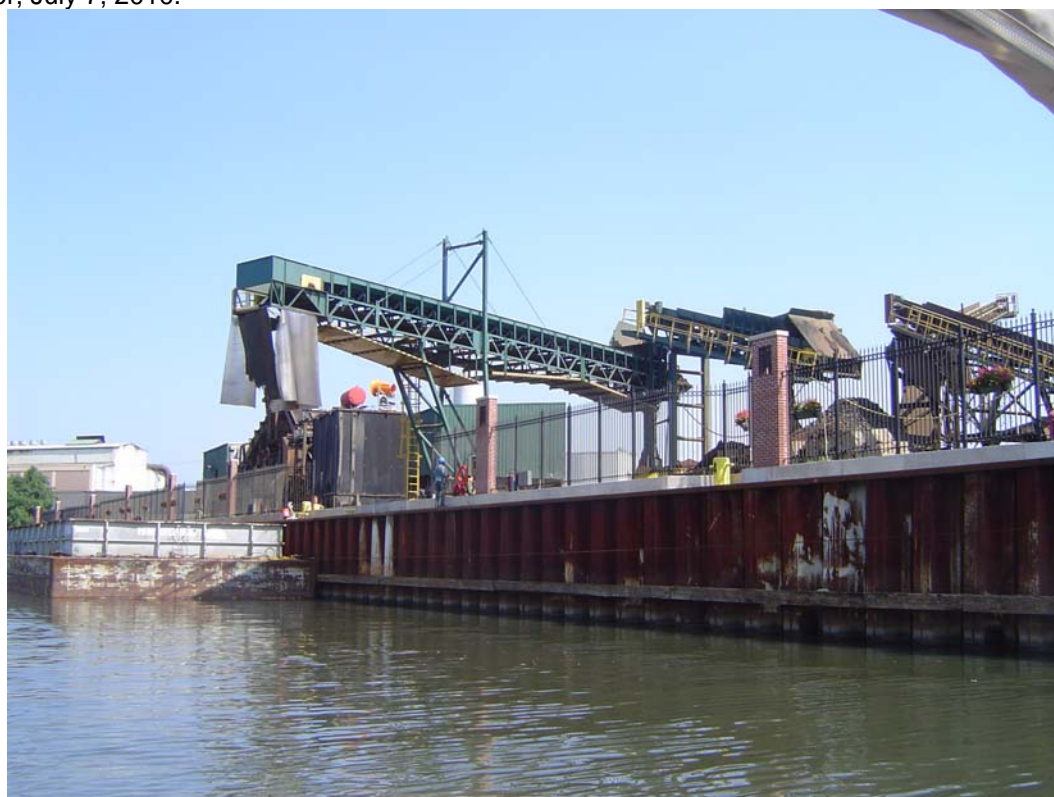
Photo 070710-02: Loading chute over at GI; combined sewer overflow (CSO) outfall nearby, according to City of Chicago. S. Meyer, July 7, 2010.

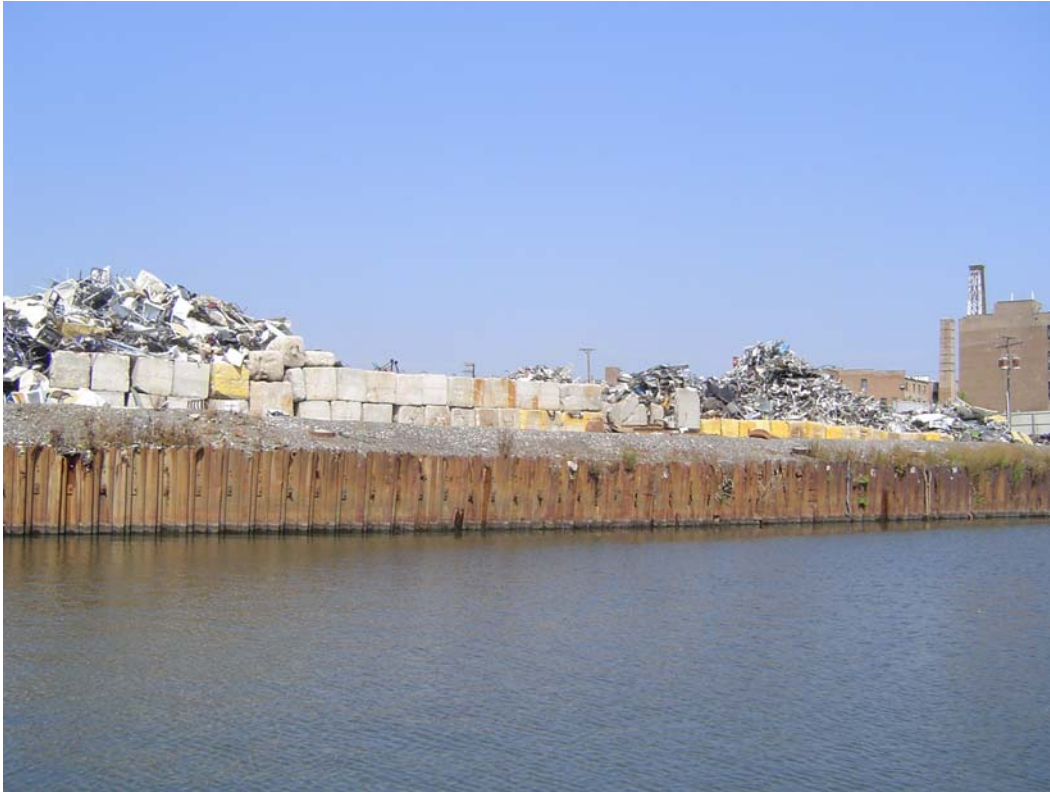
Photo 070710-03: Metals Management scrap yard on west side of river. S. Meyer, July 7, 2010.

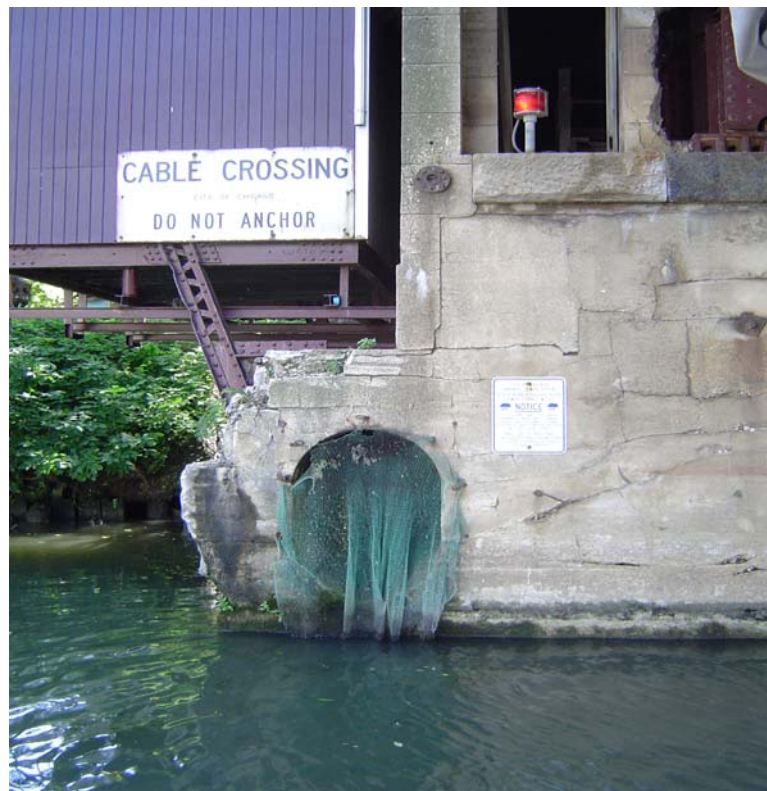
Photo 070710-04: CSO outfall #080, "netted", medium-sized, northeast corner of Cortland Avenue Bridge. S. Meyer, July 7, 2010.

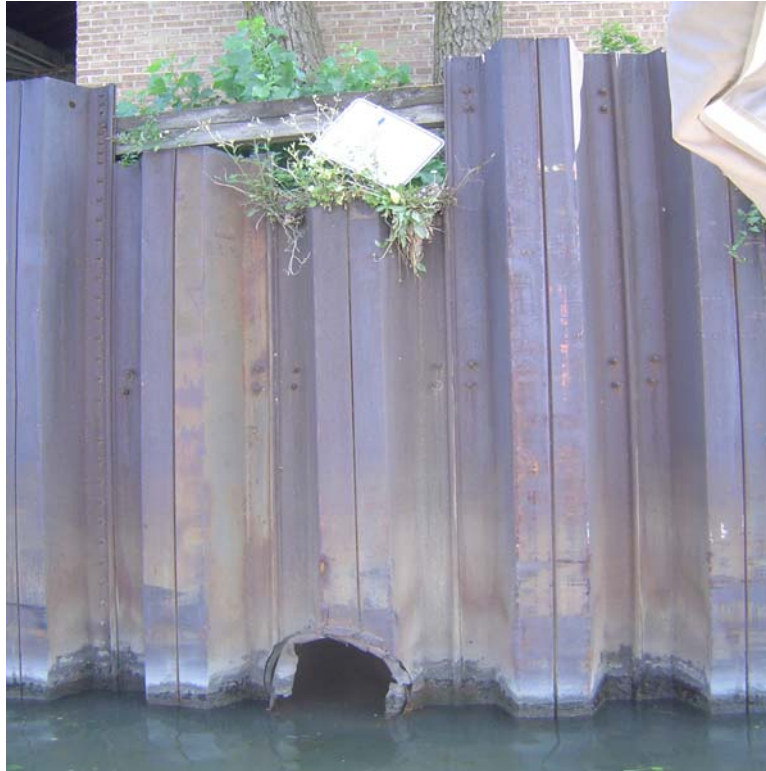
Photo 070710-05: CSO outfall #078, medium sized; brick building and palette loading at this property. S. Meyer, July 7, 2010.

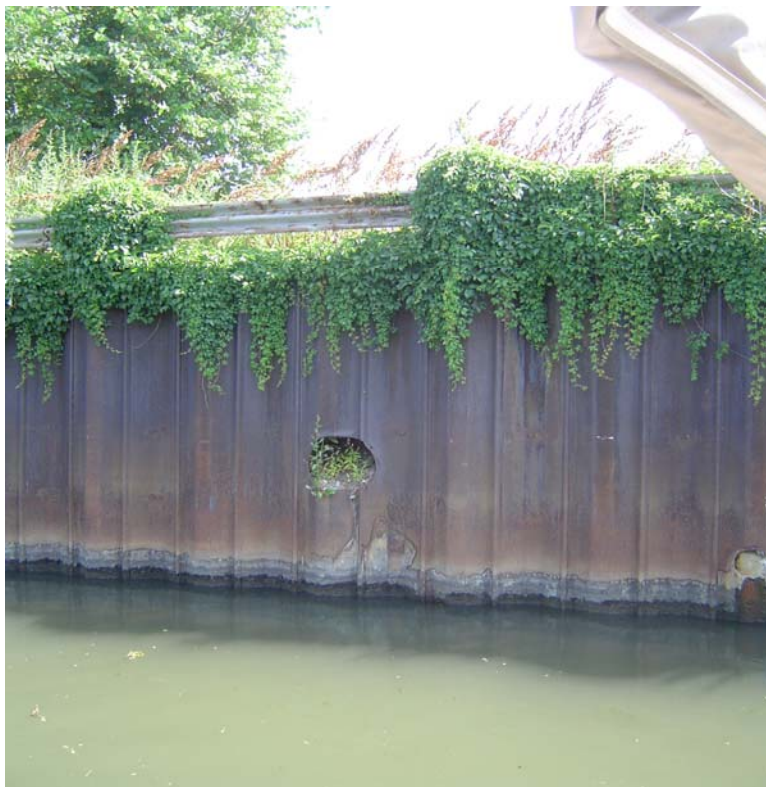
Photo 070710-06: Small, historic outfall, grown over with vegetation; steel guardrail at land edge here. S. Meyer, July 7, 2010.

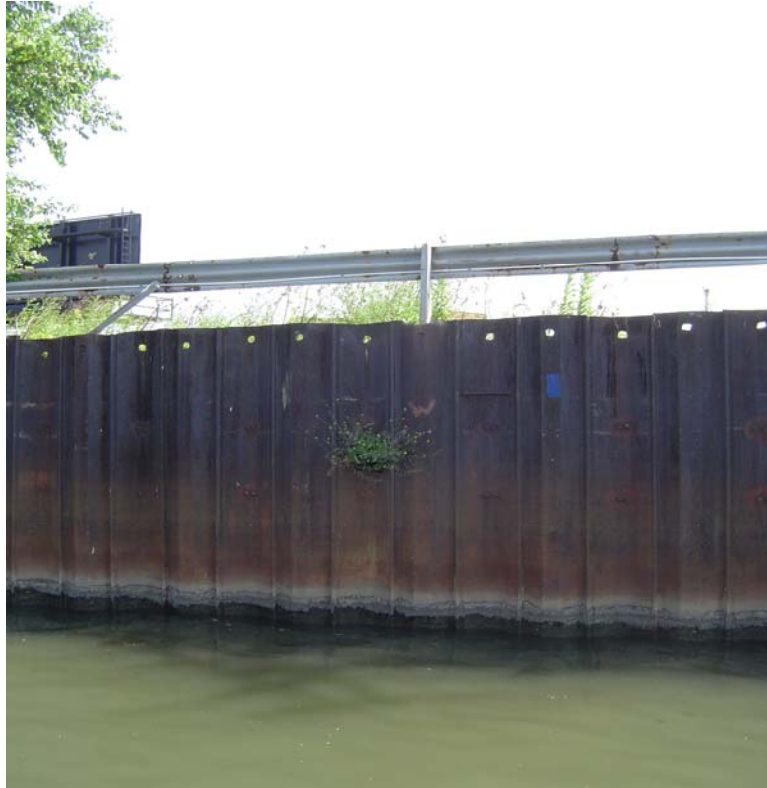
Photo 070710-07: Small, historic outfall, vegetation growing out of it. S. Meyer, July 7, 2010.

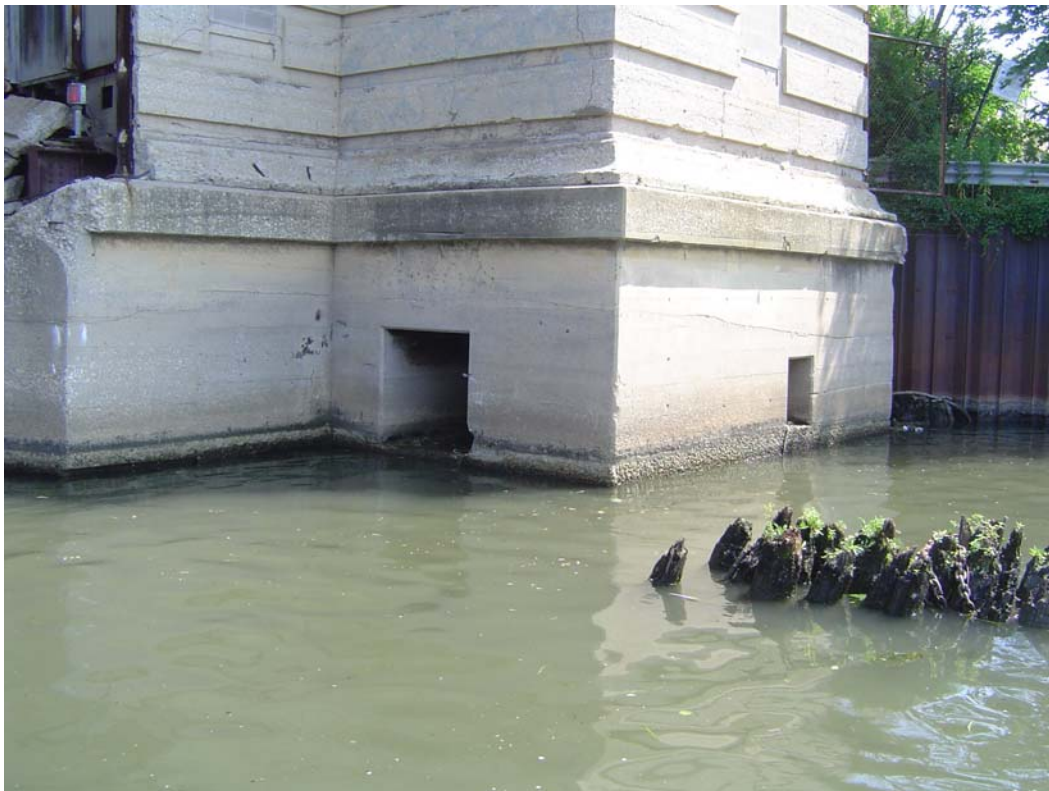
Photo 070710-08: Box culvert, southeast corner of Webster Avenue Bridge, CSO/storm sewer; aeration station upstream of here. S. Meyer, July 7, 2010.

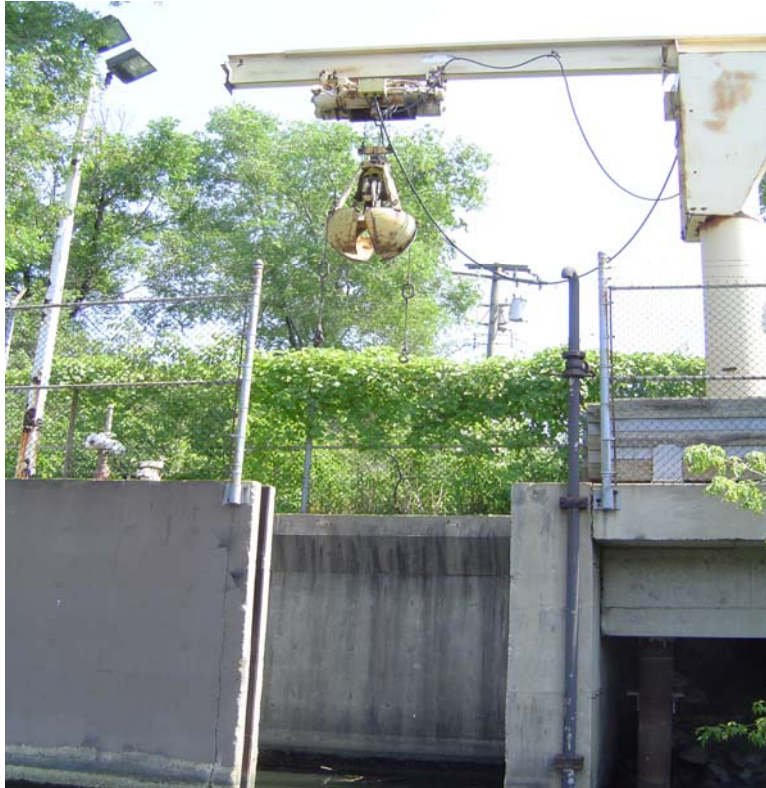
Photo 070710-09: Crane/clamshell hoist at shore just north of aeration station. S. Meyer, July 7, 2010.

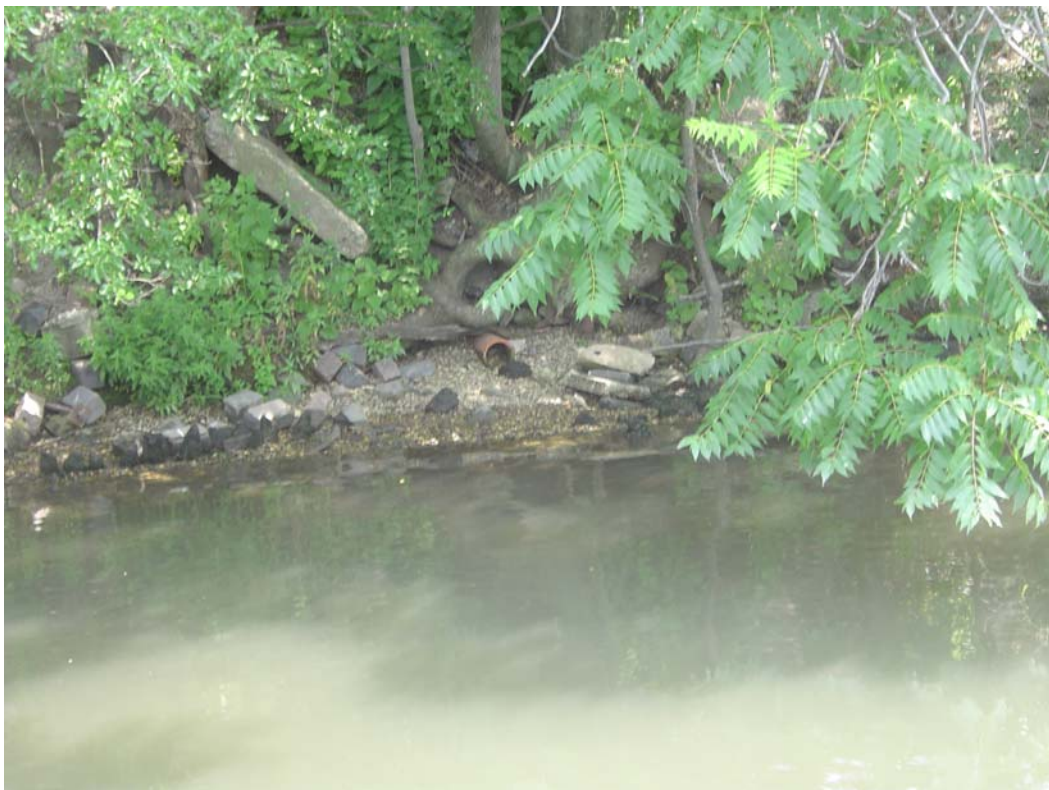
Photo 070710-10: Small, orange, clay (?), drain tile under tree roots at shoreline. S. Meyer, July 7, 2010.

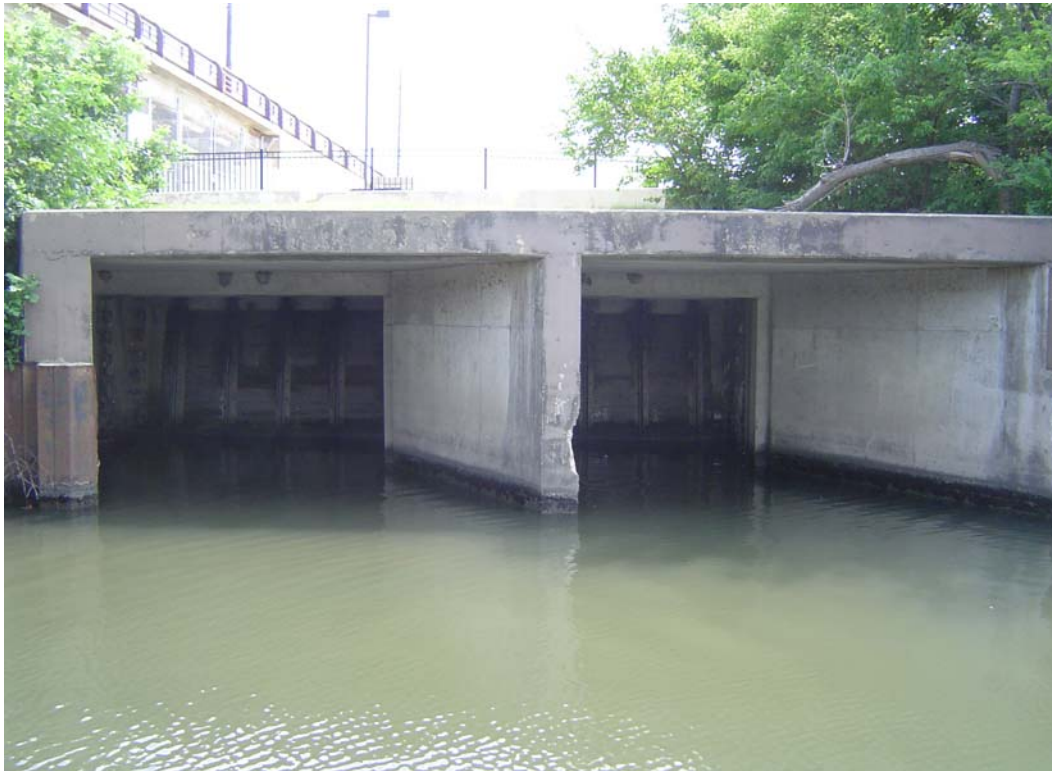
Photo 070710-11: Very large, two-box storm/CSO outfall with control gates at southeast corner of Fullerton Avenue Bridge. S. Meyer, July 7, 2010.

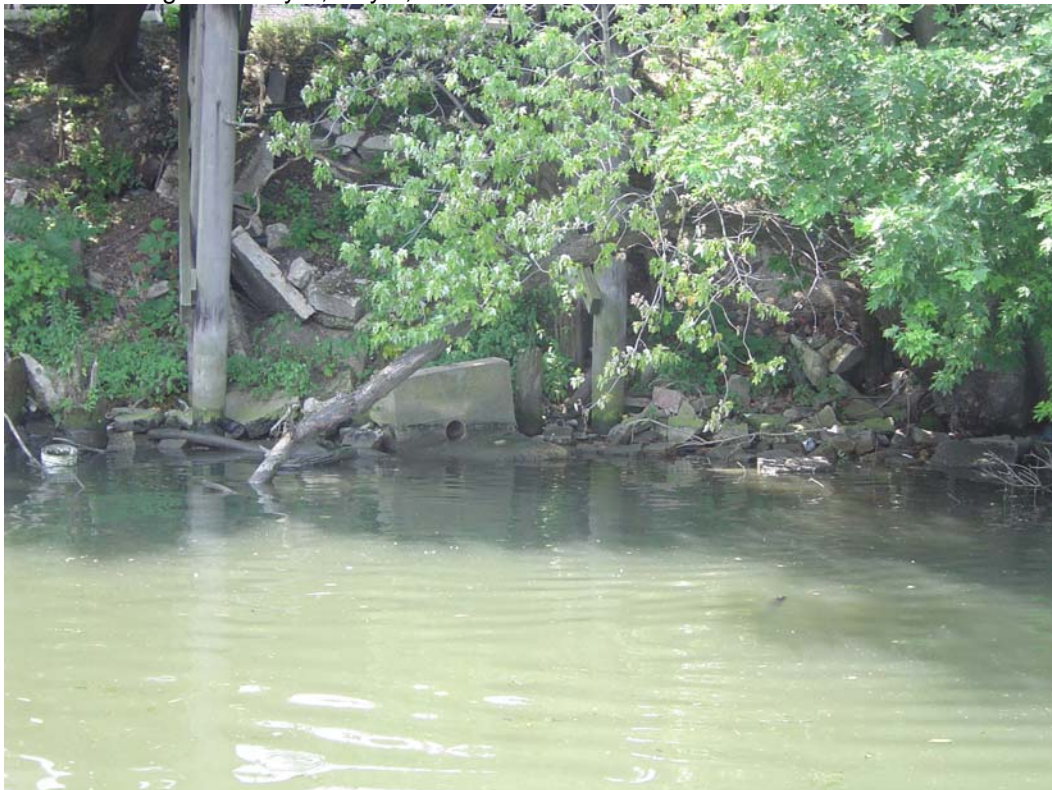
Photo 070710-12: Small (6-inch) outfall in concrete block near treated wood bridge; maybe creosote source. S. Meyer, July 7, 2010.

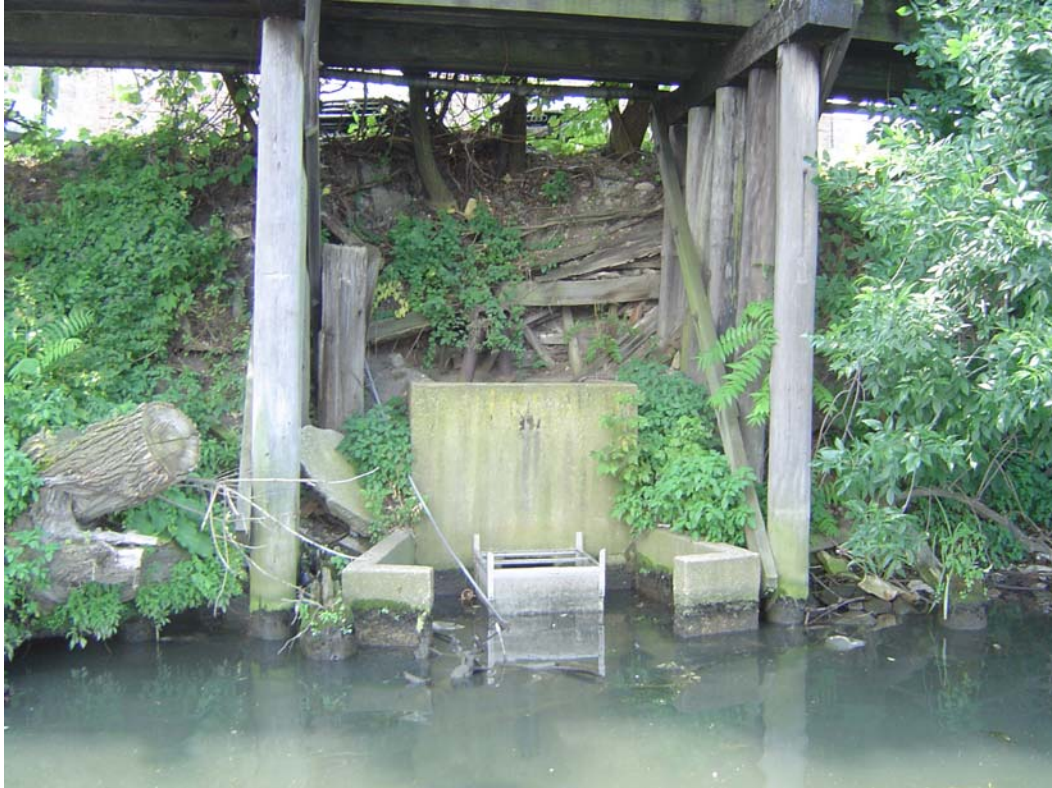
Photo 070710-13: Large, box “overflow” under same wood bridge of photo 070710-12; parking lot upland from here. S. Meyer, July 7, 2010.

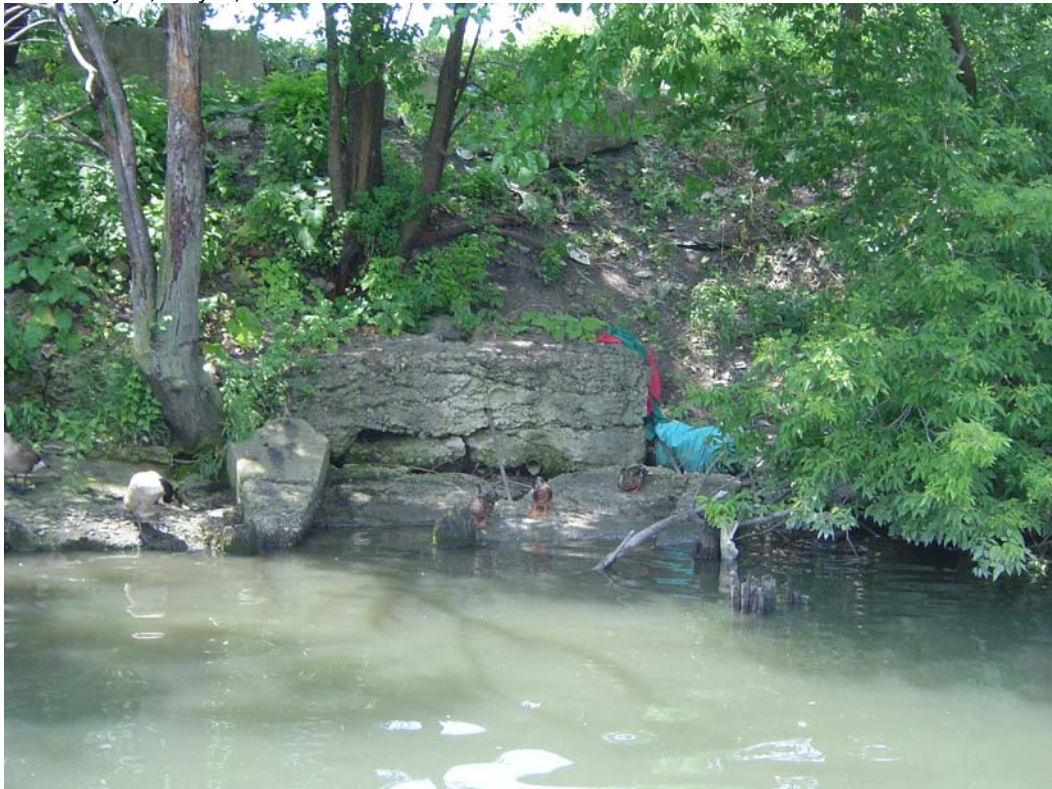
Photo 070710-14: Small (4-6 inch) pipe from crumbling concrete foundation. S. Meyer, July 7, 2010.

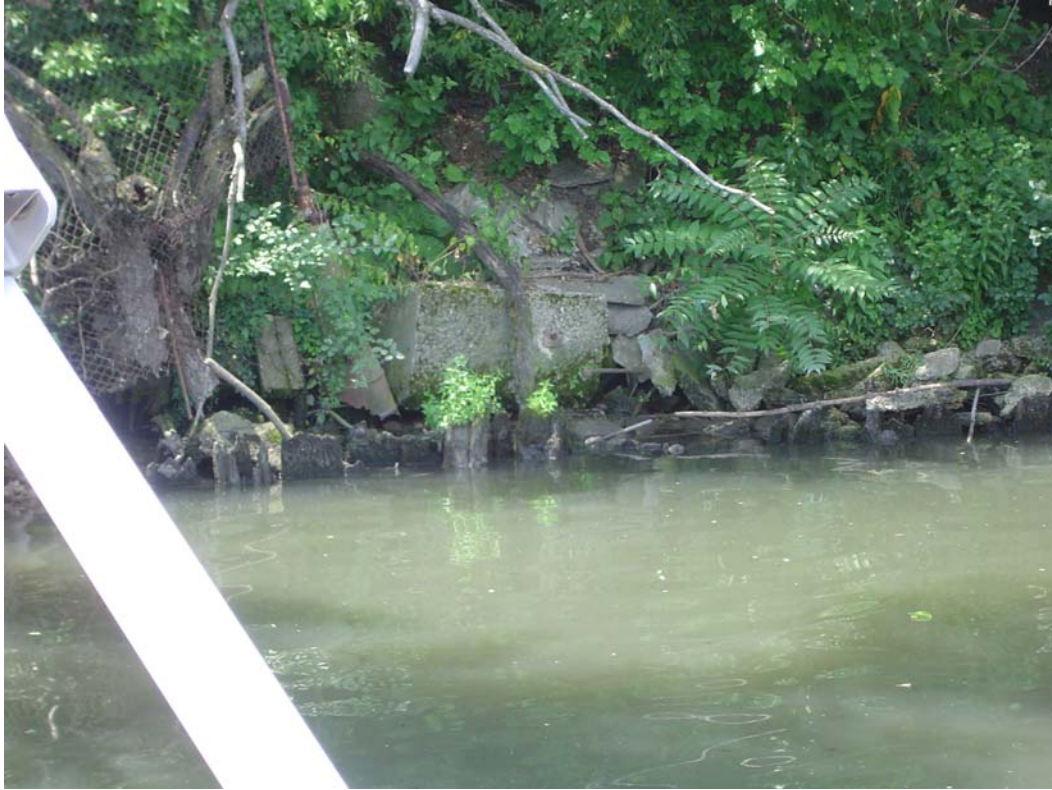
Photo 070710-15: Small outfall just upstream of concrete/foundation block; maybe PVC.
S. Meyer, July 7, 2010.

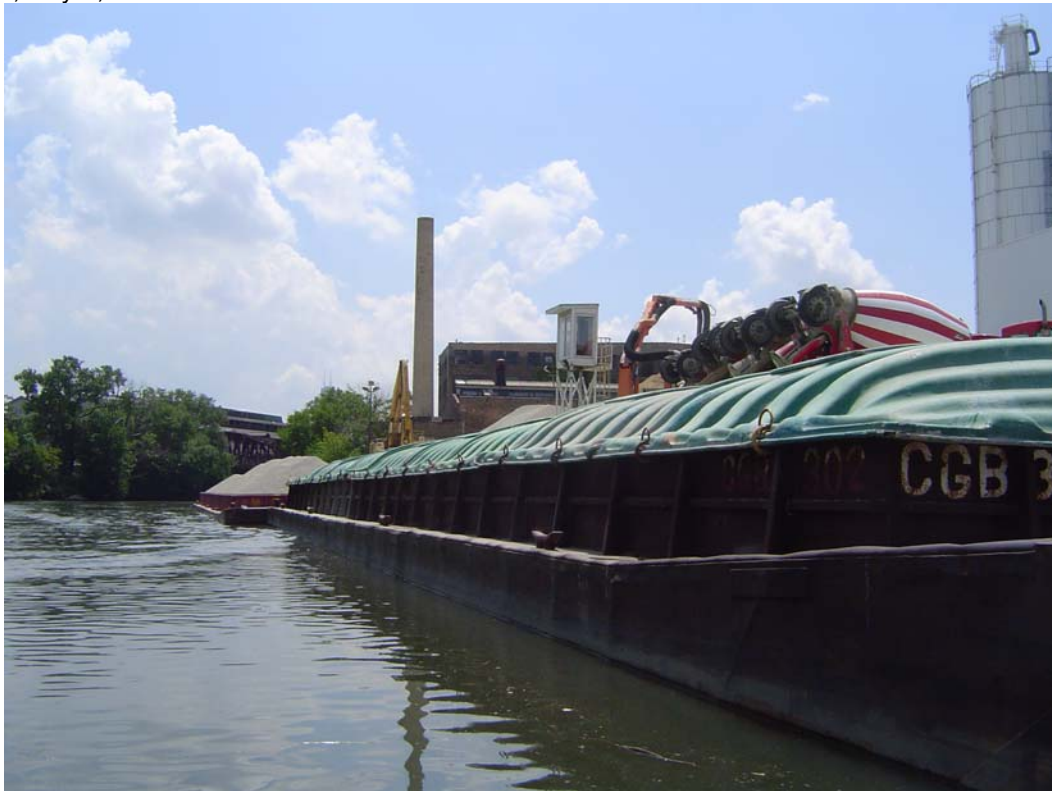
Photo 070710-16: Cement facility with large loading dock; barges docked here, wall/outfalls not visible.
S. Meyer, July 7, 2010.

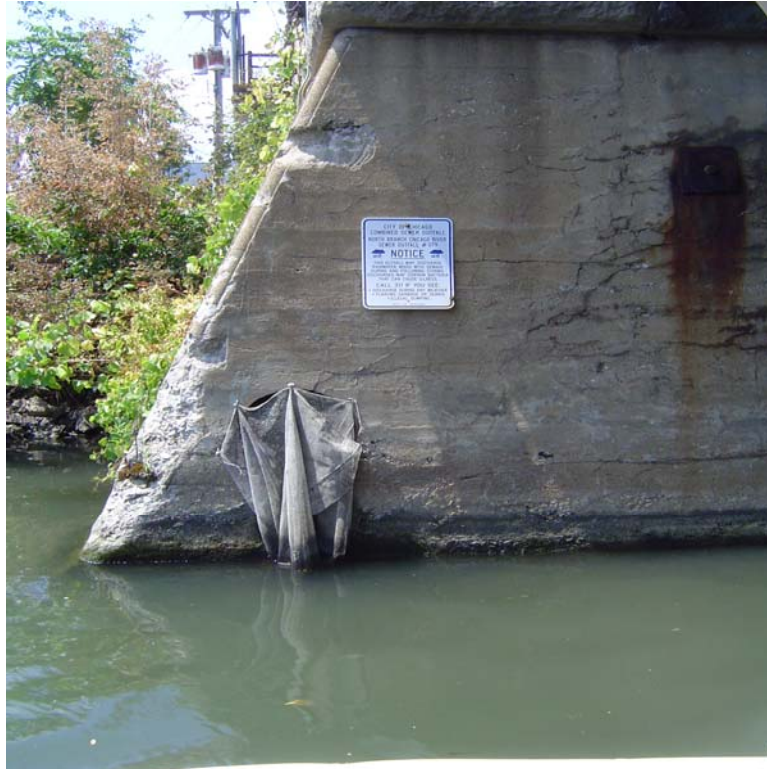
Photo 070710-17: CSO #079, large (2-foot diameter), southwest corner of Courtland Avenue Bridge; Metals Management scrap metal yard downstream of here. S. Meyer, July 7, 2010.

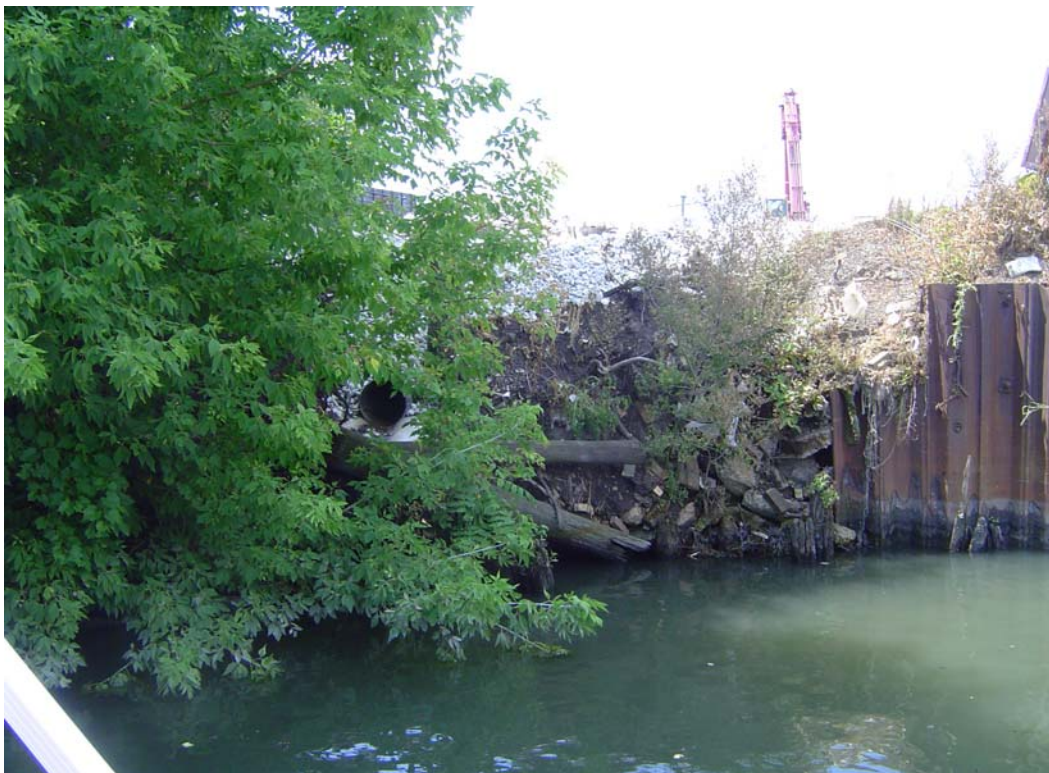
Photo 070710-18: Medium-sized (18-inch) metal pipe approximately 20 feet south of downstream end of Metals Management scrap yard wall; stormwater seepage over seawall. S. Meyer, July 7, 2010.

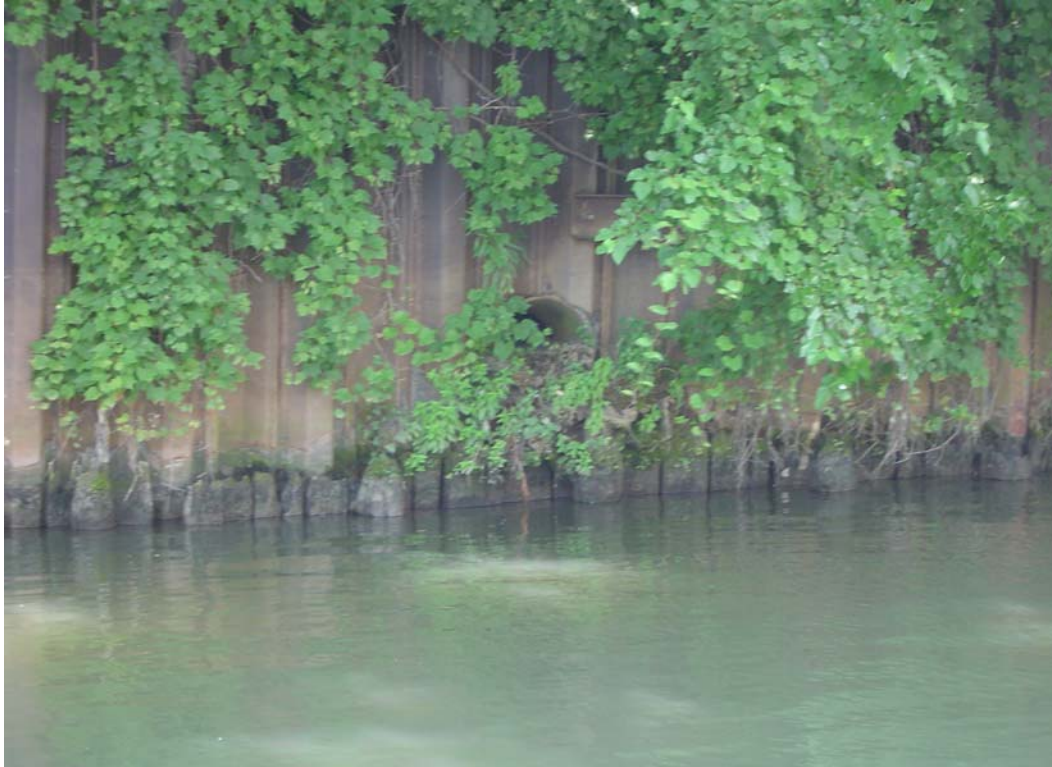
Photo 070710-19: Medium-sized (18-inch) outfall on sheet pile wall. There is another similar outfall just south of here. S. Meyer, July 7, 2010.

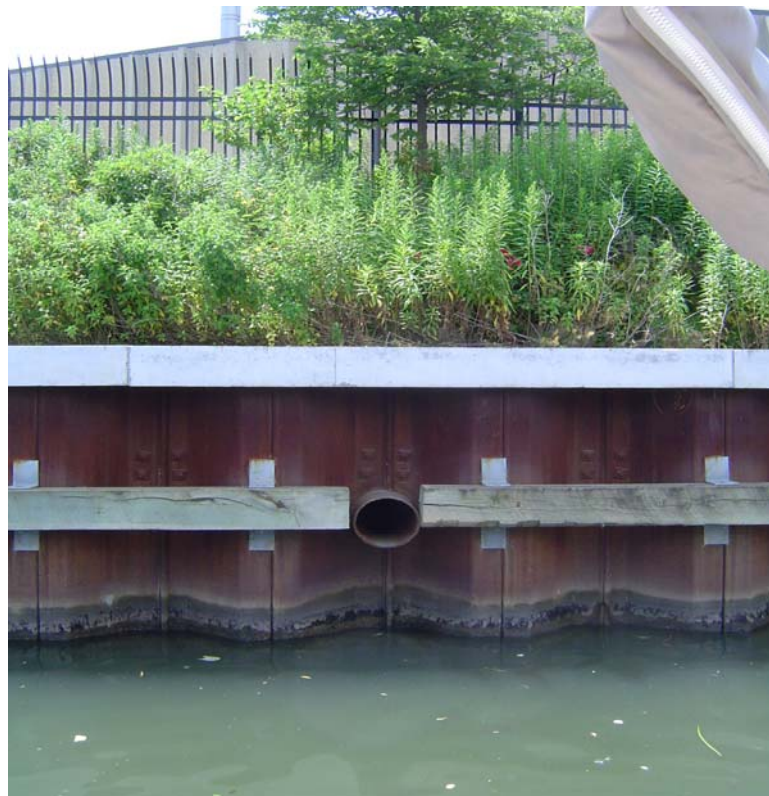
Photo 070710-20: Medium (1-foot diameter) outfall at ComEd facility. S. Meyer, July 7, 2010.

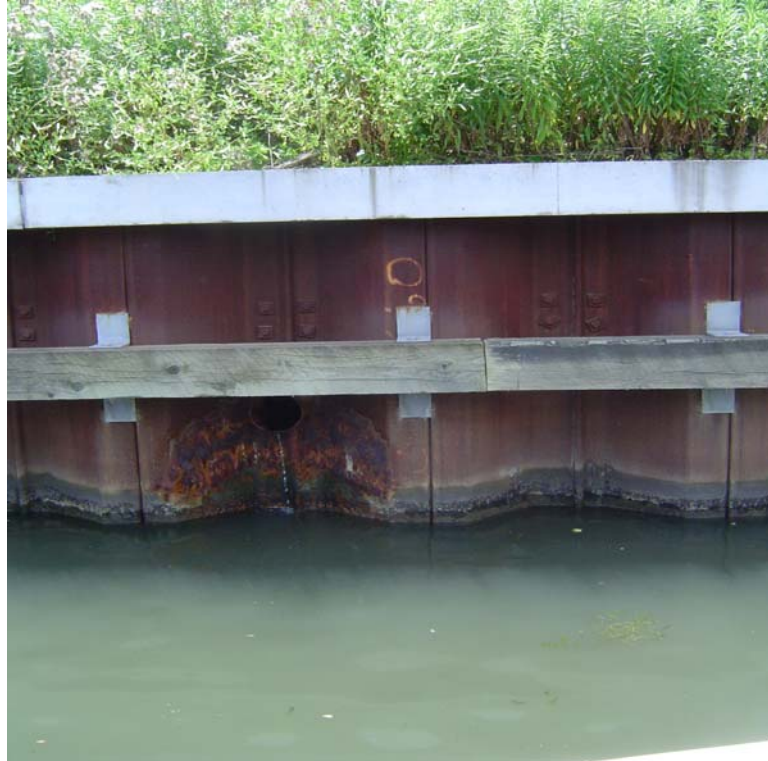
Photo 070710-21: Medium-sized outfall with water running from it (maybe ComEd). S. Meyer, July 7, 2010.

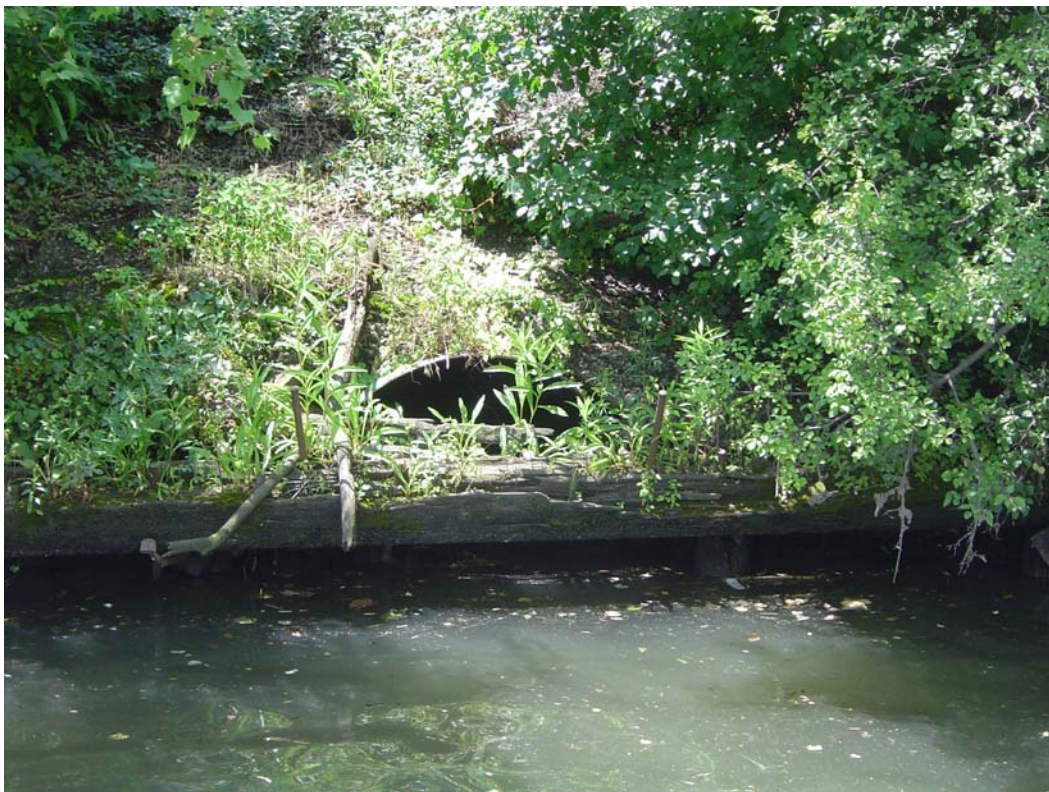
Photo 070710-22: Large, corrugated metal outfall underneath a foundation, partially obstructed by wood seawall. S. Meyer, July 7, 2010.
